[Docket No. FAA-2008-0071; Directorate Identifier 2006-SW-27-AD; Amendment 39-16291; AD 2010-10-12]

Airworthiness Directives; Bell Helicopter Textron Canada Model 222, 222B, 222U, 230, and 430 Helicopters

ACTION: Final rule.

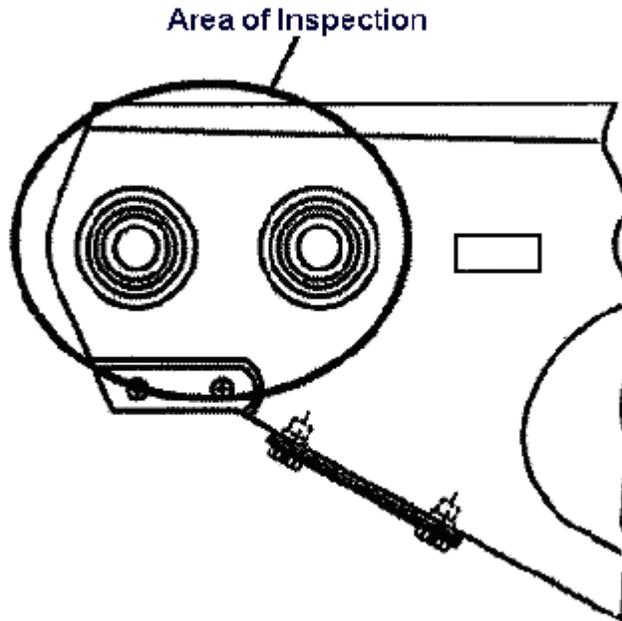
Figure 1
Blade Inspection Area

Transport Canada, the airworthiness authority for Canada, notified the FAA that an unsafe condition may exist on the specified BHTC model helicopters. Transport Canada advises of the discovery of cracked blades during scheduled inspections on three occasions. Two cracks originated from the outboard feathering bearing bore underneath the flanged sleeves. The third crack started from the inboard feathering bearing bore. Investigation found that the cracks originated from either a machining burr or a corrosion site in the bearing bore underneath the flanged sleeves.

(a) Within 3 hours time-in-service (TIS), unless accomplished previously, and thereafter at intervals not to exceed 3 hours TIS, clean and visually check both sides of each blade for a crack in the paint in the areas shown in Figure 1 of this AD. An owner/operator (pilot), holding at least a private pilot certificate, may perform this visual check and must enter compliance with this paragraph into the helicopter maintenance records by following 14 CFR 43.11 and 91.417(a)(2)(v).

P/N 222-016-001 – all dash numbers

(c) Within the next 50 hours TIS, unless accomplished previously, and thereafter at intervals not to exceed 50 hours TIS, clean the blade by wiping down both surfaces of each blade in the inspection area depicted in Figure 1 of this AD using aliphatic naphtha (C-305) or detergent (C-318) or an equivalent. Using a 10X or higher power magnifying glass, visually inspect both sides of the blade in the areas depicted in Figure 1 of this AD.

(1) If a crack is found, even if only in the paint, before further flight, remove the blade from the helicopter and proceed with the following:

(2) Remove the paint on the blade down to the bare metal in the area of the suspected crack by using plastic media blasting (PMB) or a nylon web abrasive pad. Abrade the blade surface in a span-wise direction only.

(3) Using a 10X or higher power magnifying glass, inspect the blade for a crack.

(i) If a crack is found, replace the blade with an airworthy blade before further flight.

(ii) If no crack is found in the blade surface, refinish the blade by applying one coat of epoxy polyamide primer, MIL-P-23377 or MIL-P-85582, so that the primer overlaps the existing coats just beyond the abraded area. Let the area dry for 30 minutes to 1 hour. Then, apply one sealer coat of polyurethane, MILC85285 TYI CL2, color number 27925 (semi-gloss white). Reinstall the blade.

(d) On or before 90 days after the effective date of this AD, replace any affected serial-numbered blade with an airworthy blade that has a S/N that is not subject to, or has been excepted from, the requirements of this AD. Installing an airworthy blade that is not subject to the requirements of this AD, or has been excepted from the requirements of this AD, including those blades with an "R" code in the square block below the part number field of the Data Plate, constitute a terminating action for the requirements of this AD.
